Manhole Inspection Summary

Manhole # S29Q__017MH

Insp Date: **11/4/08 2:17 PM**

Location Address: **710 W. Ostend St**

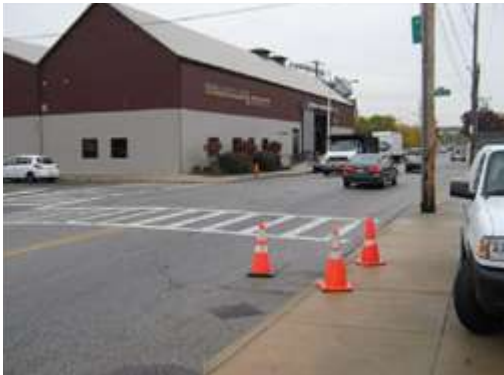
Location View

across from 710 W. Ostend St

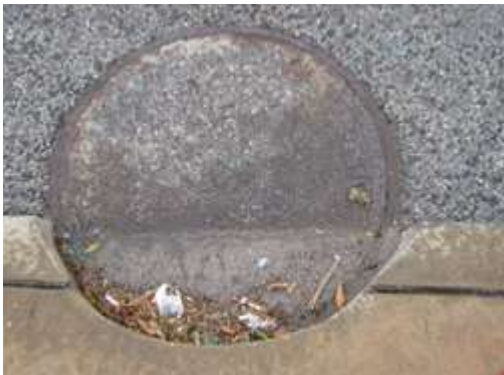
misc-4

mh cover

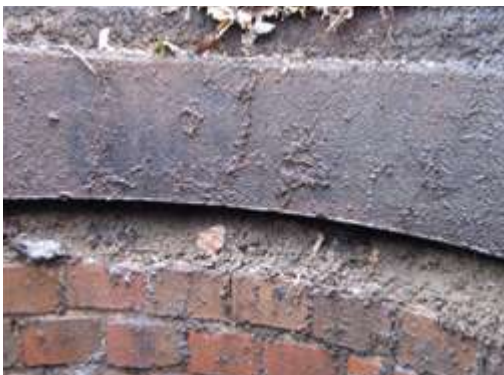
Defect 2

Condition: ☐ Sound ☐ Cracked ☐ Root Intrusion ☒ **Loose Brick** ☒ **Deteriorated**

Infiltration: ☐ None ☒ **Joint** ☐ Cracks ☐ Mortar ☐ Roots ☐ Wall

chimney deteriorated with loose bricks & signs of infiltration at joint

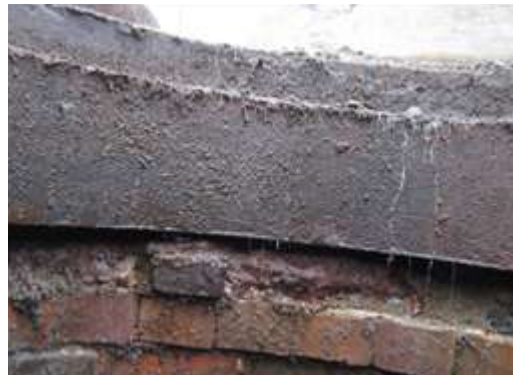
Defect 3

Frame Offset: **0** (in.) Condition: ☐ Sound ☐ Cracked ☒ **Leaks**

frame leaks

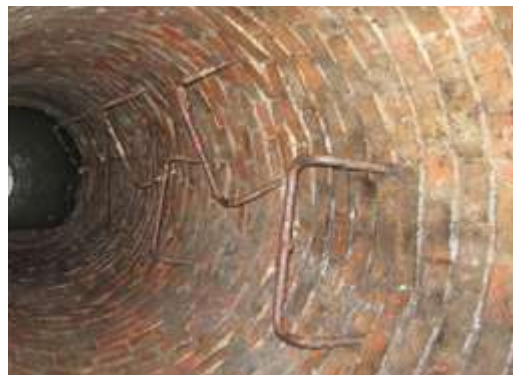
Defect 1

Steps Count: **8** Missing: **0** ☒ **Corroded**

Surcharge ☒ **Evidence Of Surcharge** Depth: **3** (ft.) ☐ Active Surcharge Present

corroded rungs, surcharge evidence

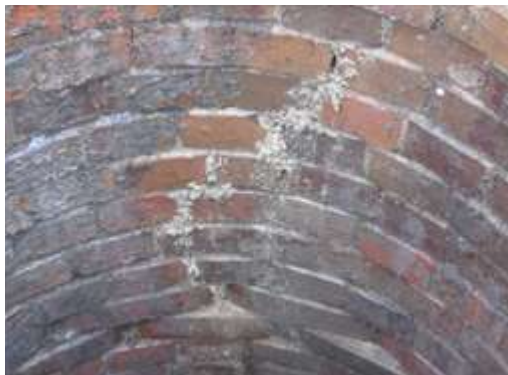
Defect 4

Condition: ☐ Sound ☒ **Cracked** ☐ Root Intrusion ☐ Loose Brick ☐ Deteriorated

cracked bricks in corbel wall

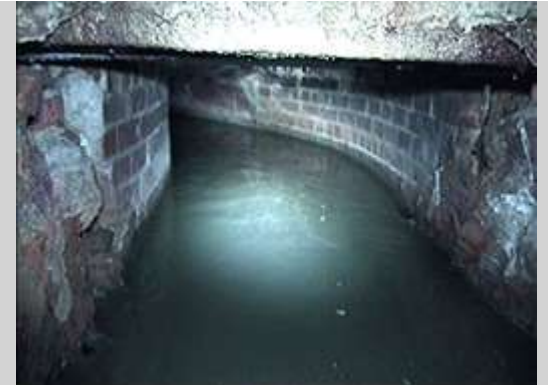
12 O'Clock Outflow

27 in. Circular Gravity Sewer
Pipe Out @ 12O'clock

Pipe Height: **27.6** (in.) Rod and Bar (Angled)
Pipe Material: **Clay** ☐ Pipe Lined
Invert Depth: **15.70** (ft.) Flow Characteristics: **Fast**
Deposits: ☒ None ☐ Mud ☐ Sludge ☐ Debris ☐ Grease
Silt Depth: **0** (in.) Deposits Extent:
Infiltration: **None** Pipe Seal Cond: **Sound**

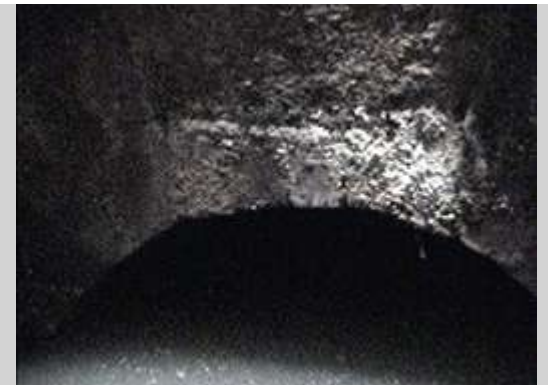
7 O'Clock Inflow

27 in. Circular Gravity Sewer
Pipe In @ 6 O'clock

Pipe Height: **30** (in.) Rod and Bar (Angled)
Pipe Material: **Clay** ☐ Pipe Lined
Invert Depth: **16.64** (ft.) Flow Characteristics: **Fast**
Deposits: ☒ None ☐ Mud ☐ Sludge ☐ Debris ☐ Grease
Silt Depth: **0** (in.) Deposits Extent:
Infiltration: **None** Pipe Seal Cond: **Sound**
